Blackstone River Watershed Association

Quinsigamond River Stream Team Shoreline Survey Report & Action Plan September 2009

Summary of Findings

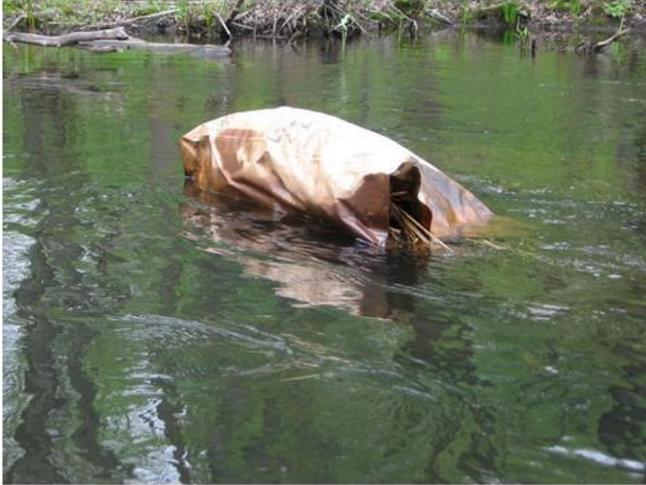
Another Vigoro bag of brush/clippings.

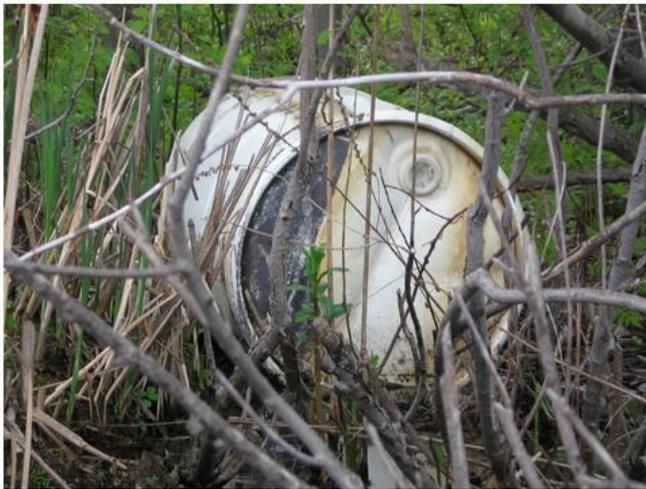
Suspicious barrel that we figured out its origin later.

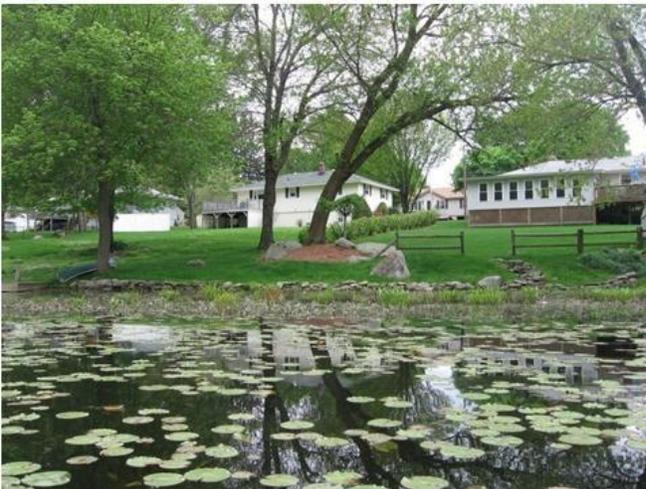
Lots of green, fertilized lawns going right down to the water...on the west, lower end of Hovey Pond.

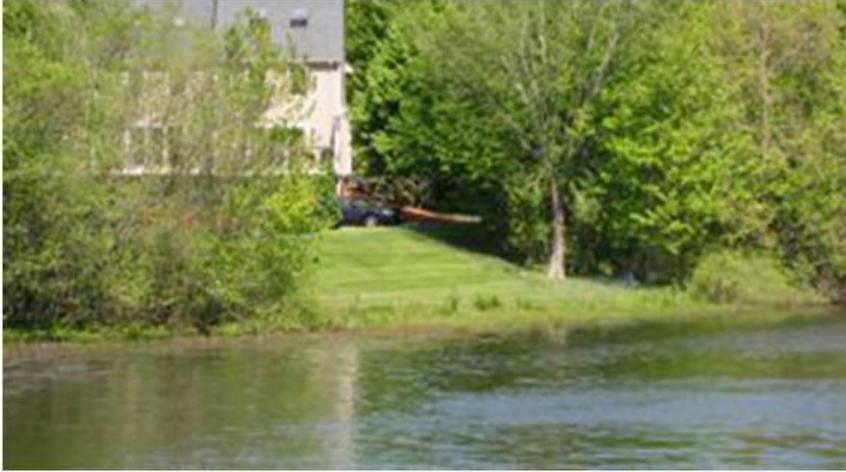
Vegetative buffer zone issues – Hovey Pond area

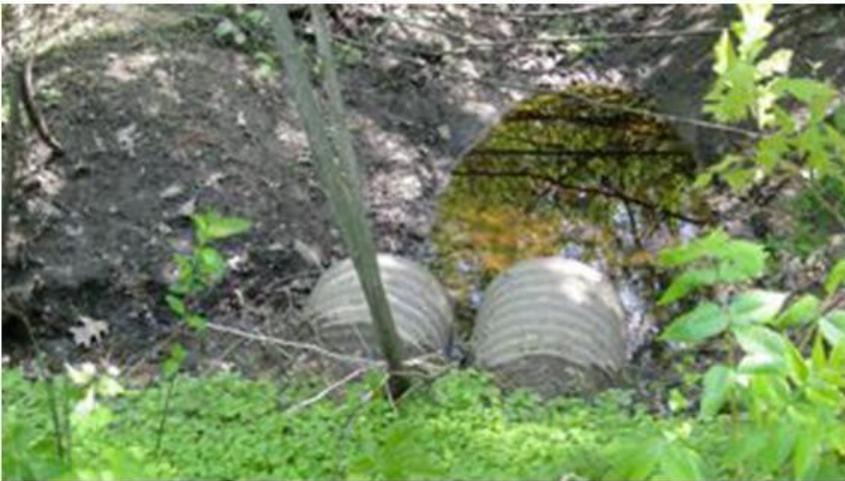
Several highway drains on Rte. 140 that fronts Washington Mills drain to a lower catch basin behind the Mill. Sand and silt collect in this area. It is noted that the State is responsible for the road salt, sand and maintenance of these drains. The drainage pipes cross under the RR easement. The responsibility for these belongs either to the State or the railroad. The pipe that exits into the wetland is silted up and has little drainage.

Silted up concrete
pipes

PROBLEMS:	ASSETS:	PRIORITIES:
<p>Problems found in your segment, such as; pipes discharging in dry weather erosion, runoff trash, dense algae, water quality problems (odor, color, oil, foam, sewage) degraded wetlands (phragmites, loosestrife) other problems (describe, give location)</p> <ol style="list-style-type: none"> 1. Clean up trash in river and at old bridge on Route 140/122 	<p>Assets found in your segment, such as: Good habitat, wildlife species, businesses or landowners using the river (in a friendly way) recreational access (canoe, trails, parks) potential recreational access potential park/conservation land (describe, give location)</p> <ol style="list-style-type: none"> 1. Excellent stewardship by Washington Mills. 2. No obvious issues from houses due to large buffer zone of trees, shrubs, and steep banks along the river. 	<p>List items from problems/assets columns that you feel need more work.</p> <ol style="list-style-type: none"> 1. Clean out catch basins that drain to wetland area (contact State) 2. Clean out pipe that is silted up at entrance to wetlands

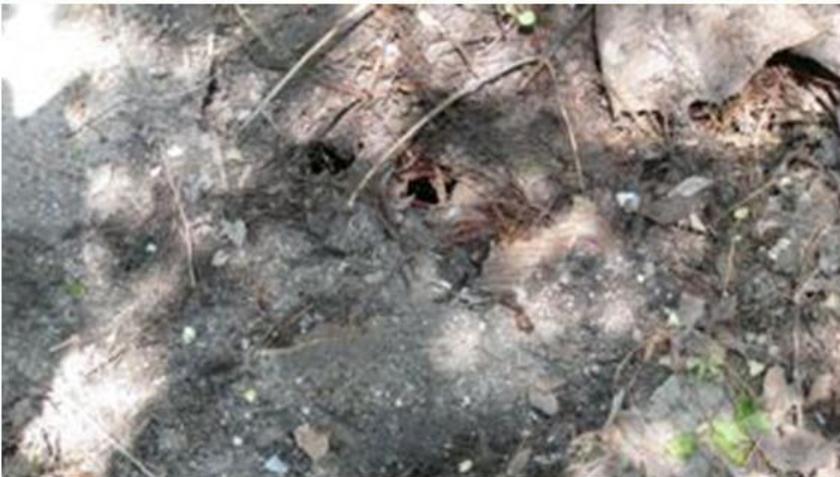
Clogged drain
Route 140

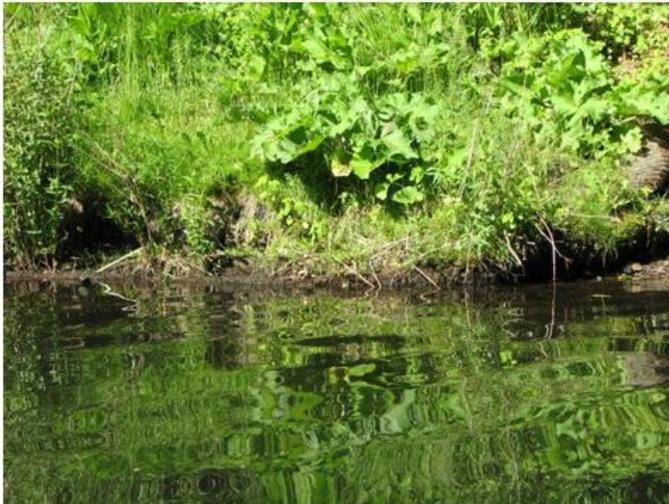
Site of previous
erosion control
project
(downstream from
Rte 122 bridge)

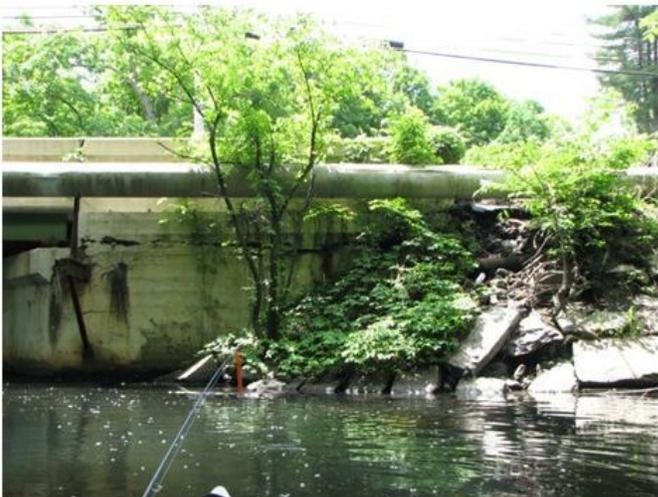
Right bank
erosion (north
side Rte 122
bridge)

3	Near Aggregate Industries	Determine, if any, impact business has had on river	
4	Northeast corner of Lake Ripple (behind car wash)	Oily sheen on surface and trash	Recheck area
4	Lake Ripple (western side)	Check pipes - no discharge but rusted and muddy/obstructed	Recheck area
5	Downstream from Brigham Hill Road	Tributary enters river through marsh. Milky colored plume for 110 yds downstream N42 deg 12.470/W71deg 41.866	Recheck area
5	Downstream from Brigham Hill Road (East side)	Sandy delta	Check where this area is and ID where this is coming from
6	Downstream from Pleasant St Bridge	2 pipes discharging in dry weather	Monitor
7	Riverview area	Water being drawn by pump	Need to see if being used and what for. Determine if legal.
	Reporting to Town Officials		
3	Downstream from Route 122 bridge	Roadway runoff through asphalt swale causing erosion	Contact DPW
3	Route 122 bridge	Erosion on both sides of bridge heading upstream	Contact DPW

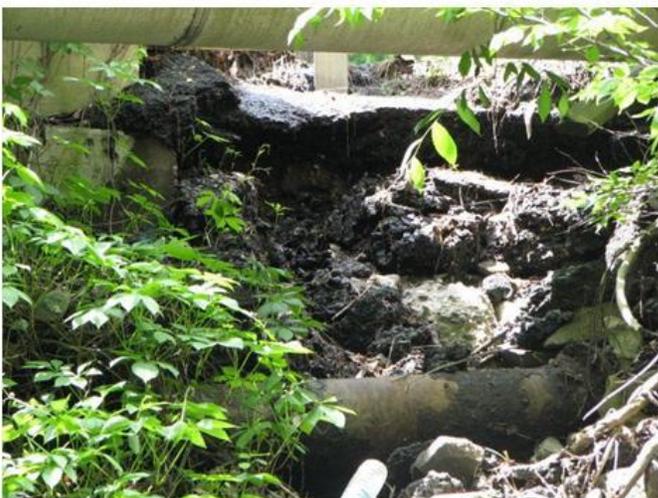
Close up of
erosion

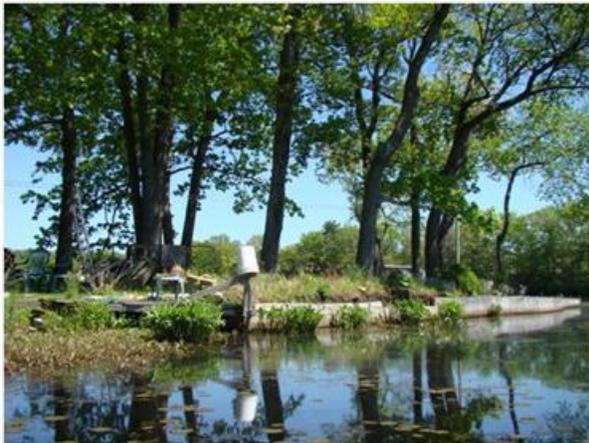
One of several houses with failing retaining walls

PROBLEMS:	ASSETS:	PRIORITIES:
<p>Problems found in your segment, such as; pipes discharging in dry weather erosion, runoff trash, dense algae, water quality problems (odor, color, oil, foam, sewage) degraded wetlands (phragmites, loosestrife) other problems (describe, give location)</p> <ol style="list-style-type: none">1. Erosion of private property is significant where retaining walls have begun to fall apart. Pictures show collapse of both stone and wood structures.	<p>Assets found in your segment, such as: Good habitat, wildlife species, businesses or landowners using the river (in a friendly way) recreational access (canoe, trails, parks) potential recreational access potential park/conservation land (describe, give location)</p> <ol style="list-style-type: none">1. Conservation land on right bank offers significant wildlife habitat, as well as riparian buffer and controls erosion. There are two wood duck boxes, though there was no evidence of use at this time.	<p>List items from problems/assets columns that you feel need more work.</p> <ol style="list-style-type: none">1. New retaining walls for private property to reduce seepage of fertilizers into river.

4	Pond near Lion's Club	Outfall pipe from pond blocked/pond issues (?)	Dredging project/cleaning
4	Lake Ripple western shore cottages	Retaining walls collapsing	Contact Con Com
4	Riverbank abutting High School	Deep gully	Contact DPW
4	Eastern shore of Lake Ripple	Overgrowth of vegetation (caused by runoff from road)	Revisit project with DPW
7	Fisherville Dam	No signage	Contact Jean Burnat (dam owner) to make suggestions
	Trash		
1	Upstream from Hovey Pond dam	Light trash in cove	
2	Washington Mills - parking lot by restaurant	Old washing machine	
4	Lake Ripple (closer to Route 122 end)	Trash	
4	Lake Ripple (parts on northern and southern	Trash/barrels

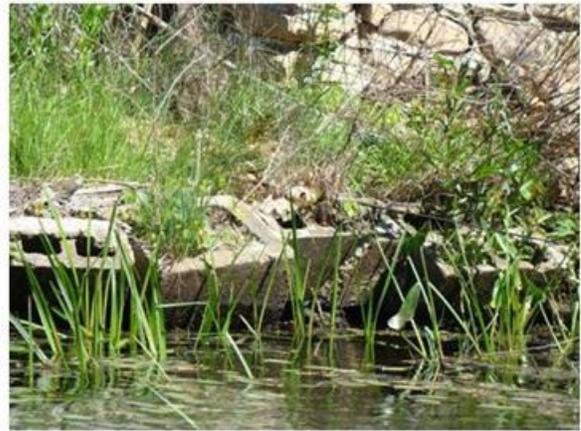
Close up of failed retaining wall

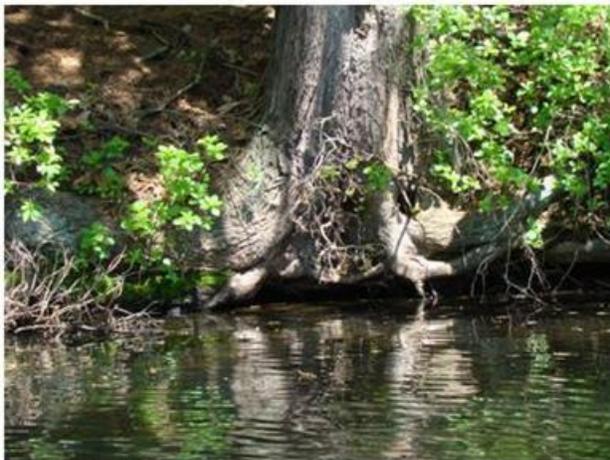
Bank erosion

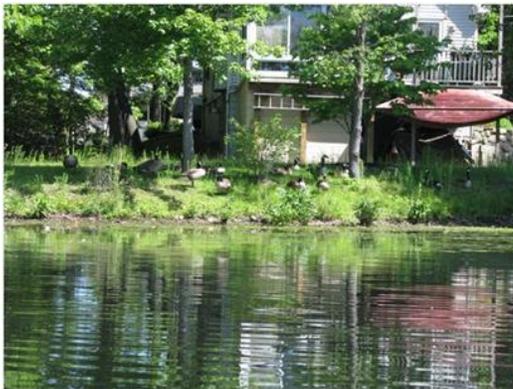
One of several houses with buffer zone issues—Lake Ripple (eastern segment)

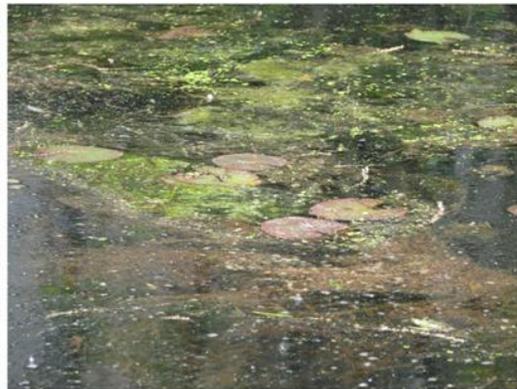
We also checked a creek at the northeast corner. It had lots of trash and a sheen over the water. There was also lots of overgrowth. Businesses nearby included a car wash. Also dumpsters and parking lots border this section.

Northeast corner—film and algae blooms

PROBLEMS:	ASSETS:	PRIORITIES:
<p>Problems found in your segment, such as; pipes discharging in dry weather erosion, runoff trash, dense algae, water quality problems (odor, color, oil, foam, sewage) degraded wetlands (phragmites, loosestrife) other problems (describe, give location)</p> <ol style="list-style-type: none"> 1. Erosion. Some along peoples' lawns and undercut banks along south shore by High School. 2. Pollution. Lots of trash closer to the Route 122 end of the Lake. Also trash along some parts of the northern and southern shores. Runoff from peoples' lawns and parking lots of businesses on the east side. 3. Overgrowth in northeast corner and spots of algae blooms in/on water. 	<p>Assets found in your segment, such as: Good habitat, wildlife species, businesses or landowners using the river (in a friendly way) recreational access (canoe, trails, parks) potential recreational access potential park/conservation land (describe, give location)</p> <ol style="list-style-type: none"> 1. Nice cover on the northern shore where its vegetated. Good habitat for muskrats and some birds. 2. Along part of Rte 122 there is a small patch of wetland with good plant cover (reeds and sedges) although some trash is caught in it. 	<p>List items from problems/assets columns that you feel need more work.</p> <ol style="list-style-type: none"> 1. Trash is fairly problematic. Could use a cleanup. 2. The creek on the northeast corner of the lake was in terrible condition. Trash and an oily wax/sheen over the water. Possibly from nearby car wash? Runoff from parking lots and lawns are possible to blame too.

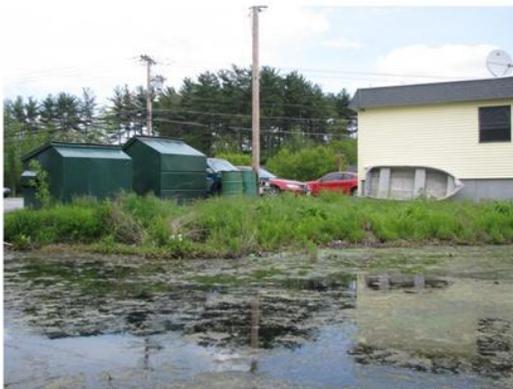
Several businesses (northeast corner) with dumpsters and 55 gallon drums near water

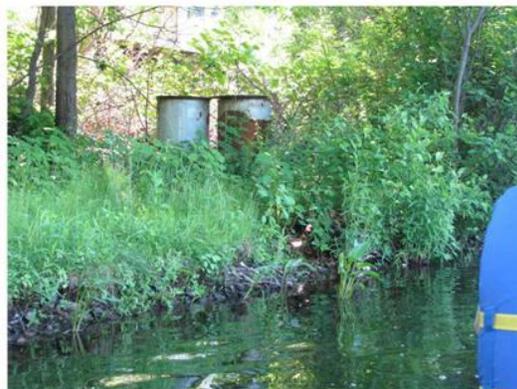
55 gallon drums along river bank

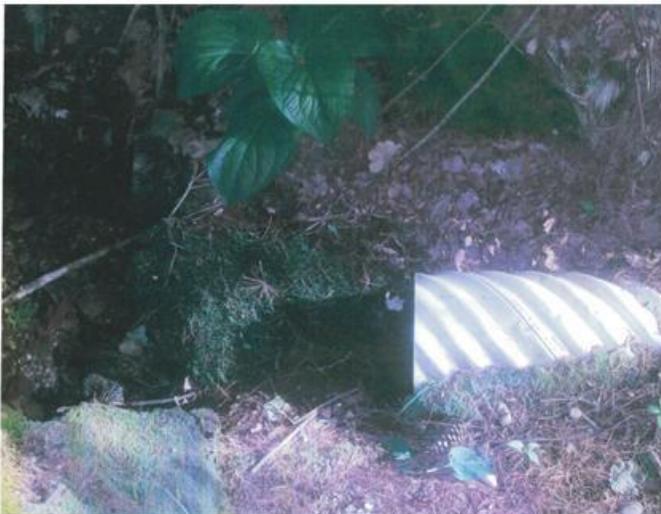
Outflow from soccer field drainage
– very green moss

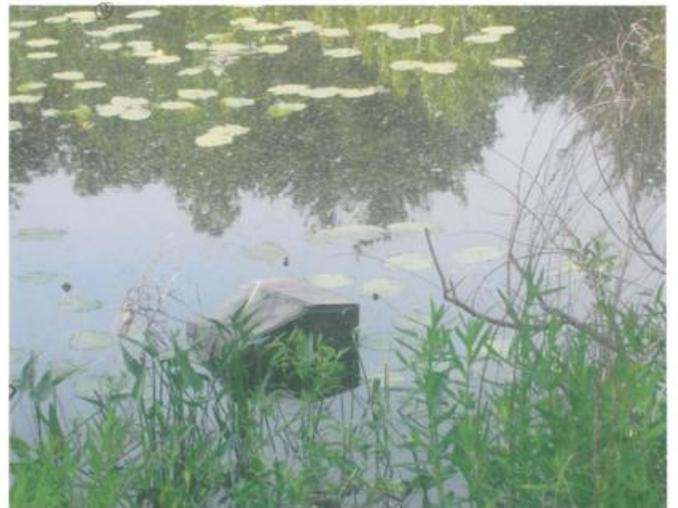
Old TV dumped in river

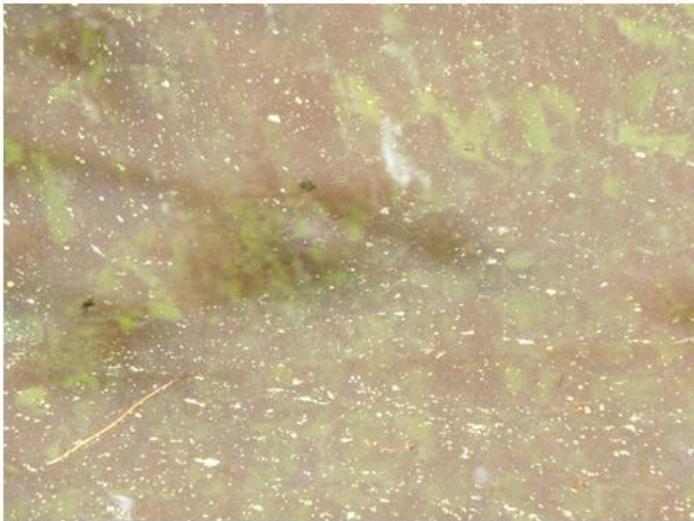
Downstream river
bottom consists of
dark green algae
for ½ mile

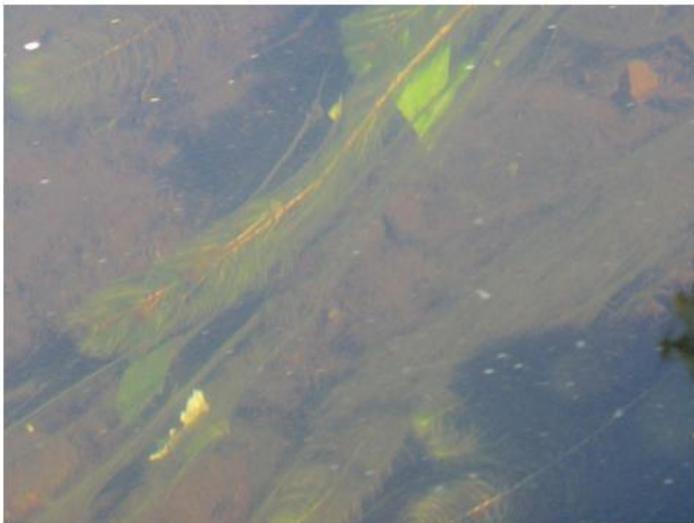
Thick patches of
milfoil

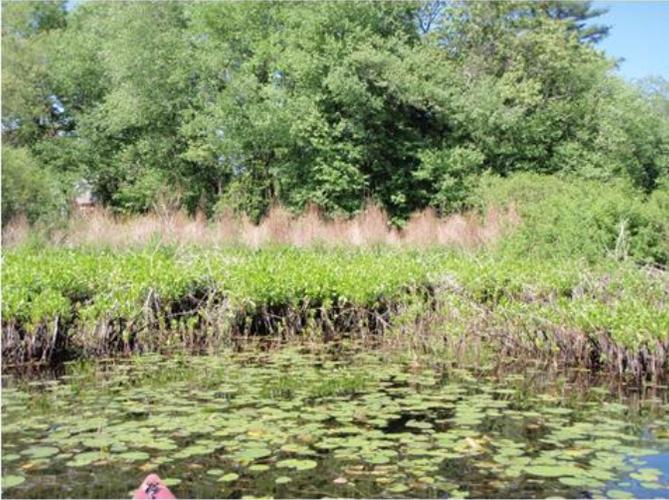
On the west (right) side of the river, on the downstream side of Brigham Hill Road a small stream enters the river after passing through a marsh adjacent to the river. The water entering the river from this stream appears to be cloudy and milky colored and creates a cloudy plume in the river that is noticeable for at least 100 yards downstream. The land alongside the river is mostly wooded and undeveloped throughout this section. Two more open wetland areas border the river farther downstream in this section; both are heavily infested with purple loosestrife.

Downstream from
Brigham Hill Road
– wetland areas
infested with
purple loosestrife

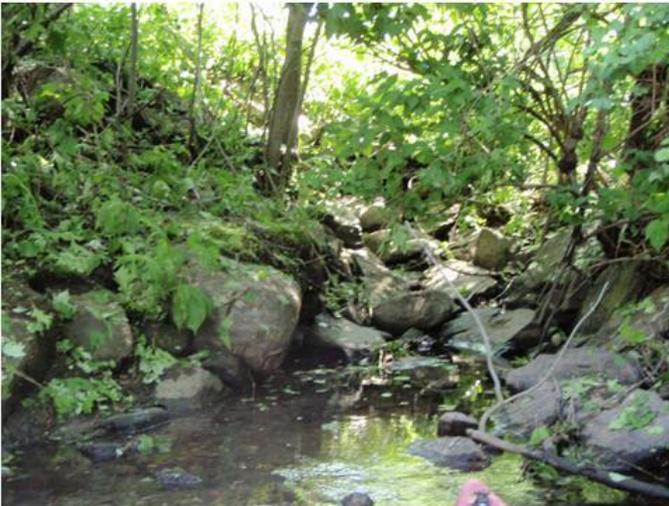
River inlet – water
appearance
cloudy with plume
for 100 yards

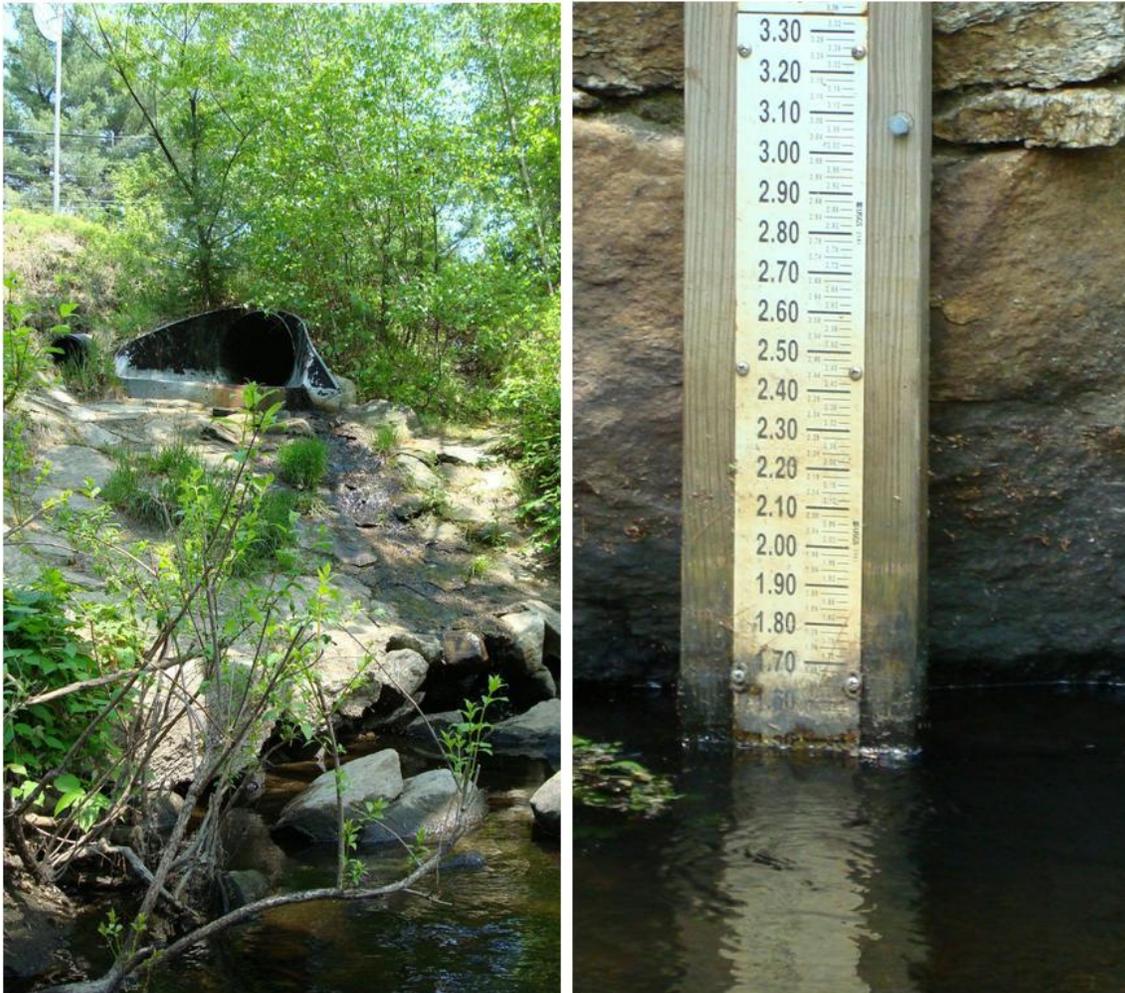
Two areas of water running from pipes into the river are noted on the map. Water appeared clear and odorless. Water flows constantly, even during dry weather.

Pleasant Street Bridge – (left) drain pipe has dry weather discharge (right) water depth at time of survey

PROBLEMS:	ASSETS:	PRIORITIES:
<p>Problems found in your segment, such as; pipes discharging in dry weather erosion, runoff trash, dense algae, water quality problems (odor, color, oil, foam, sewage) degraded wetlands (phragmites, loosestrife) other problems (describe, give location)</p> <ol style="list-style-type: none"> 1. Some purple loosestrife 2. Two pipes discharging in dry weather. 	<p>Assets found in your segment, such as: Good habitat, wildlife species, businesses or landowners using the river (in a friendly way) recreational access (canoe, trails, parks) potential recreational access potential park/conservation land (describe, give location)</p> <ol style="list-style-type: none"> 1. Good habitat. 2. Wildlife is abundant. 3. Canoe access at Pleasant Street Bridge. 	<p>List items from problems/assets columns that you feel need more work.</p> <ol style="list-style-type: none"> 1. Monitor Loosestrife growth. 2. Monitor pipes #1 and 2

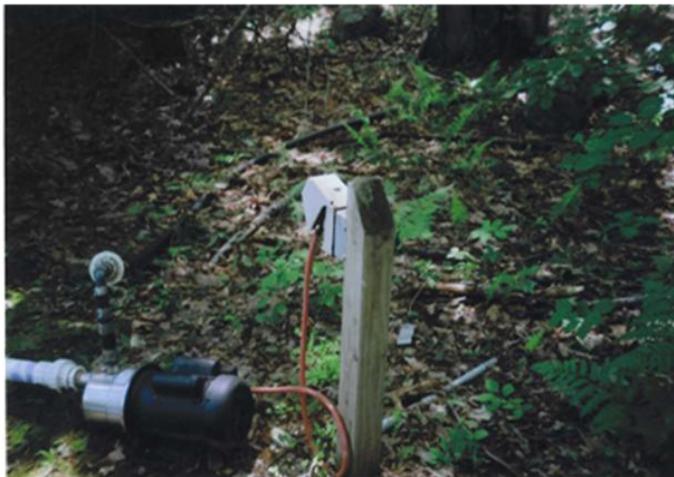
Observed first of several "pumping stations" with an electrical conduit coming from the residential area leading to a pump at the water's edge. An estimated 4" PVC pipe ran from the water to a hose that goes underground at the top of ridge behind the houses. At this point, the stream is ~ 20' wide. Opposite bank (left) had plowed fields behind houses and road.

One of several
pumping stations
found along this
stretch

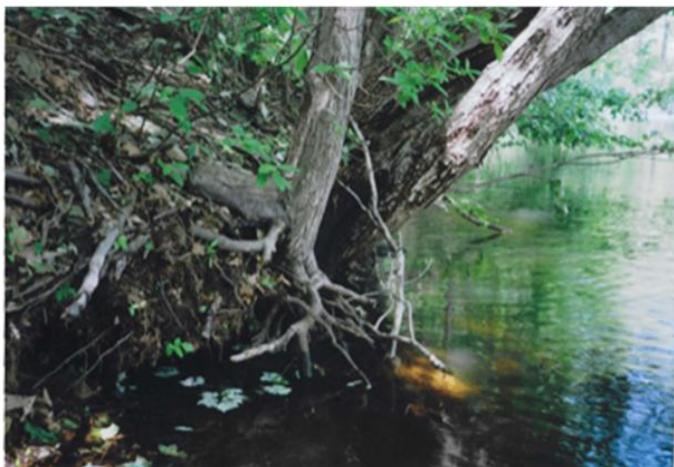
Eroded and
undercut
embankment

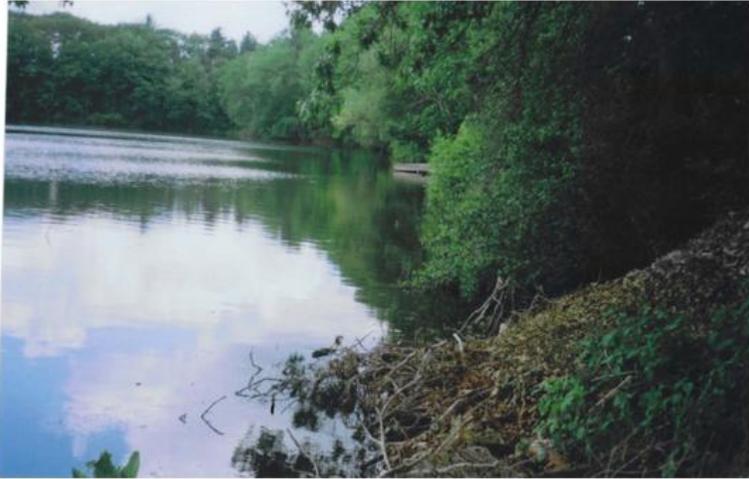
Yard debris
dumped near
river's edge

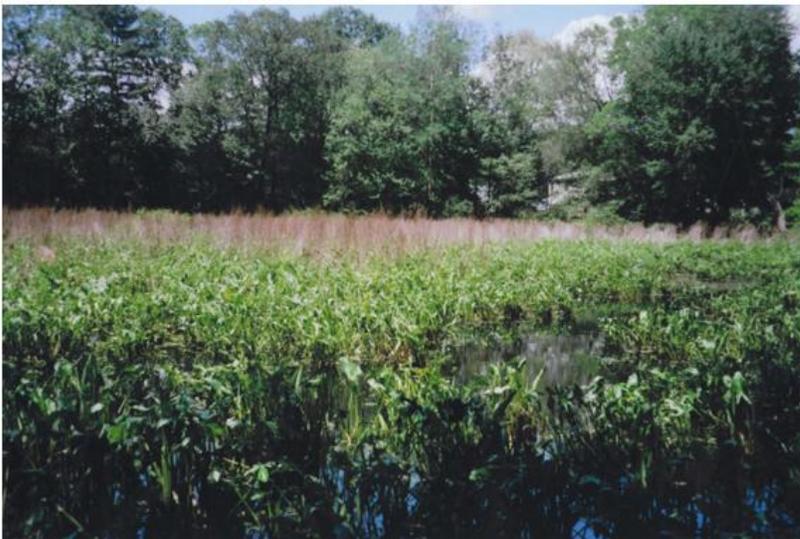
Wetland
vegetation
including purple
loosestrife

PROBLEMS:	ASSETS:	PRIORITIES:
<p>Problems found in your segment, such as; pipes discharging in dry weather erosion, runoff trash, dense algae, water quality problems (odor, color, oil, foam, sewage) degraded wetlands (phragmites, loosestrife) other problems (describe, give location)</p> <p>Water is being drawn off by landowners via pumps in several locations.</p> <p>Some areas of erosion/undercutting of bank.</p> <p>Purple loosestrife present at marshy inlet across from gravel pit.</p> <p>Sunrise Residential development is densely populated – lots of treated green lawns, paved driveways = runoff.</p>	<p>Assets found in your segment, such as: Good habitat, wildlife species, businesses or landowners using the river (in a friendly way) recreational access (canoe, trails, parks) potential recreational access potential park/conservation land (describe, give location)</p> <ol style="list-style-type: none">1. Landowners report moderate recreational use-canoeing, kayaking, fishing.2. Good wildlife habitat on upper portion of this section. Amphibians, reptiles, small mammals, song birds, water birds, aquatic invertebrates.	<p>List items from problems/assets columns that you feel need more work.</p> <ol style="list-style-type: none">1. Determine impact of pumping stations on water quality/quantity.2. Develop plan to remove loosestrife from otherwise healthy marsh area on lower stretch.
